Understanding, Diagnosing, and Repairing Leaks in Water-Cooled Generator Stator Windings

Joseph A. Worden
Jorge M. Mundulas
GE Power Systems
Schenectady, NY

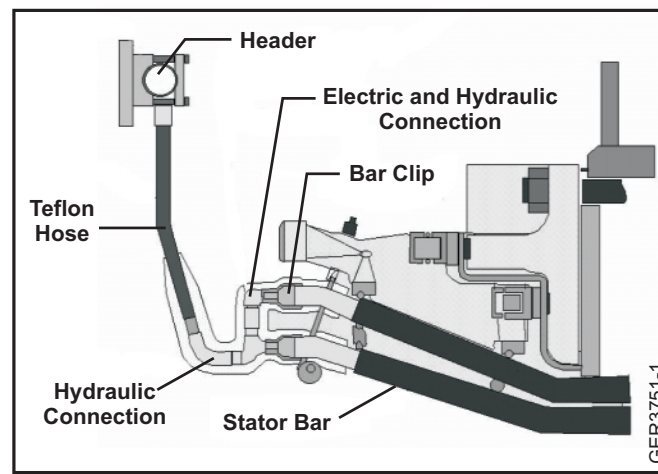
Figure 1. Typical stator end winding configuration

Figure 1 depicts a typical stator end winding configuration. Small leaks in these locations typically will not result in winding damage so long as hydrogen gas pressure is maintained above the stator cooling water pressure. However, capillary action can cause water to leak from a bar even though gas pressure is maintained higher than the cooling water pressure. Larger leaks can be detected by on-line testing methods and Vacuum and Pressure Decay Tests, which are discussed in more detail later.

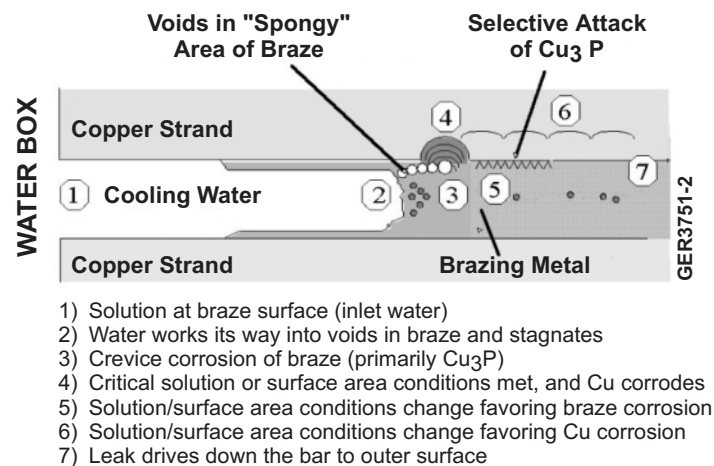
Figure 2. Crevice corrosion mechanism

- **Phase 1.** The first stage of the corrosion process consists of corrosion of the braze alloy inside the clip at the strand ends. Water works its way into existing small voids at the braze surface (due to the "spongy" nature of the braze) and stagnates. If conditions are right (i.e. void size), crevice corrosion of the braze takes place attacking the phosphorus rich phase of the braze alloy. Initial void sizes increase as material corrodes. The water chemistry changes to phosphoric acid as a result of crevice corrosion of the braze alloy. The Phase I process is limited by the crevice reaching critical volume, solution chemistry and precipitating out phosphate salt along the surface of the braze, which slows/stops further corrosion.

- **Phase 2.** The second stage of corrosion begins if the copper strand is contacted by the void as it grows. This causes a corrosive attack of the copper strands by the phosphoric acid solution created by corrosion of the braze alloy. The corrosion of the copper strands takes place preferential to the braze alloy and at a higher rate. The depth into the copper is limited and roughly constant (approximately 0.015 inches),

The corrosion mechanism changes (due to a change in water chemistry) and the phosphorus-rich phase of braze is again attacked. Then, as the solution chemistry changes due to phosphorus being added to the solution, preferential attack of the copper occurs. The mechanism switches back and forth from crevice corrosion of the braze alloy to acid attack of the copper as the leak path makes its way down the strand. *Figure 2* illustrates the crevice corrosion process.

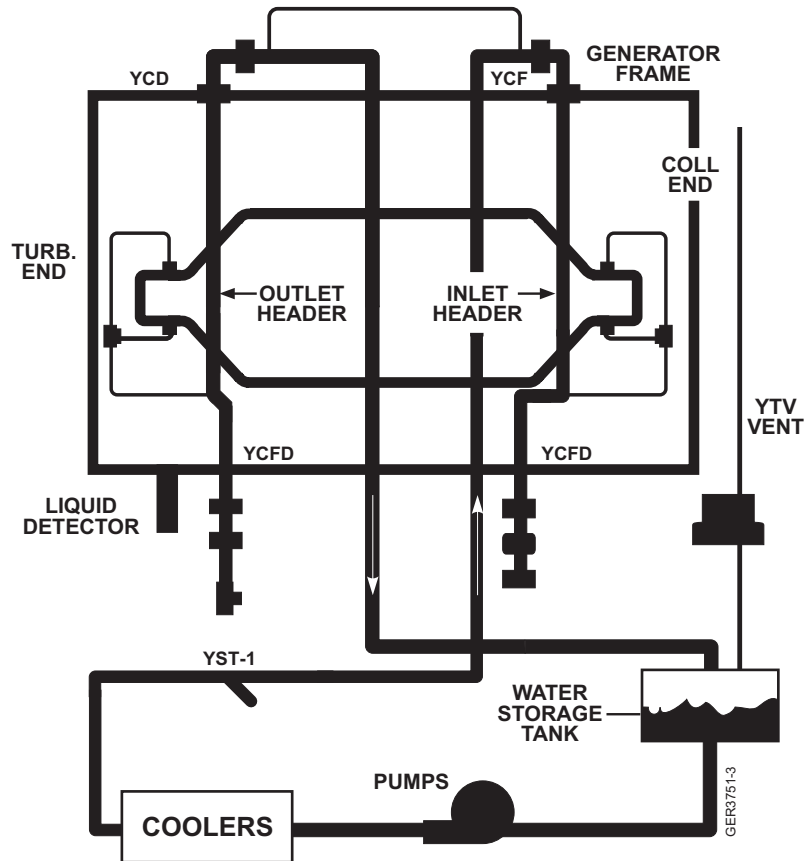
Figure 3. Stator cooling water system

- **The presence of hydrogen at the YTV vent.** (See Figure 3.) If water is found in the liquid detector, the YTV vent should be checked for hydrogen. The water is likely to be coming from a stator winding leak if the vent flow test results indicate a problem. If the vent hydrogen flow is "normal", an alternate source of water should be explored.

Excessive hydrogen gas flowing out of the stator water cooling system vent indicates that a large leak within the stator winding is likely. The stator water cooling system is a hydraulically closed system except for the YTV vent, which is designed to allow for water expansion and contraction caused by temperature changes during operation. The deionized water remains aerated by virtue of the YTV vent. Since hydrogen pressure is normally higher than water pressure, a leak in the winding may show up as excessive hydrogen flow through the vent. Hydrogen pressure inside the generator is the only possible source of hydrogen to this system. Accurate measurements of hydrogen flow are quite difficult and subject to error. Also, some uncertainty is present when attempting to differentiate between hydrogen flow due to a leak and that due to Teflon™ hose permeation. During operation, the hydraulic hoses can be the source of up to 2 ft³ of hydrogen flow per day. Through routine monitoring of the vent flow, winding leaks can be detected by noting a steady upward trend or step increases in hydrogen flow through the vent. GE recommends

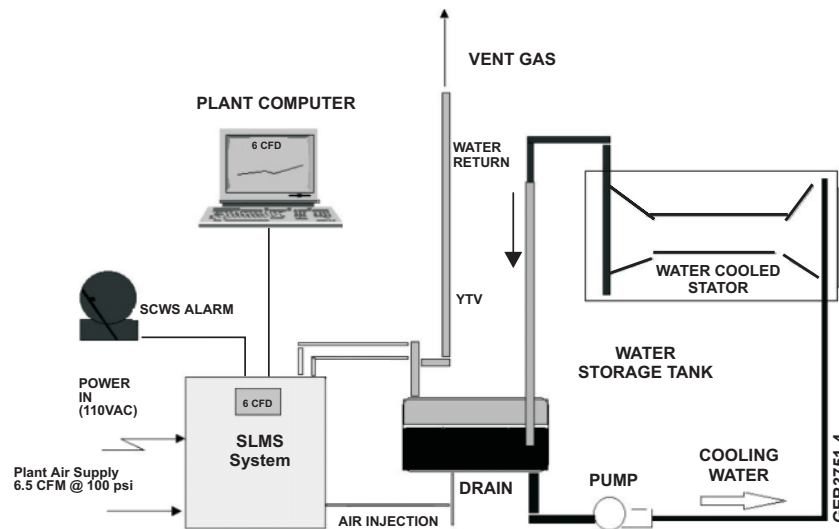
Figure 4. Typical Stator Leak Monitoring System (SLMS)

GE has developed a Stator Leak Monitoring System (SLMS) which is highly recommended for:

- Oxygenating stator cooling water to the recommended level
- Monitoring the level of hydrogen escaping out of the YTV vent

Measurement of the hydrogen content and gas flow provides an accurate measurement of hydrogen leakage through the stator winding. The level of hydrogen leakage is directly related to a leak in the water-cooled stator winding.

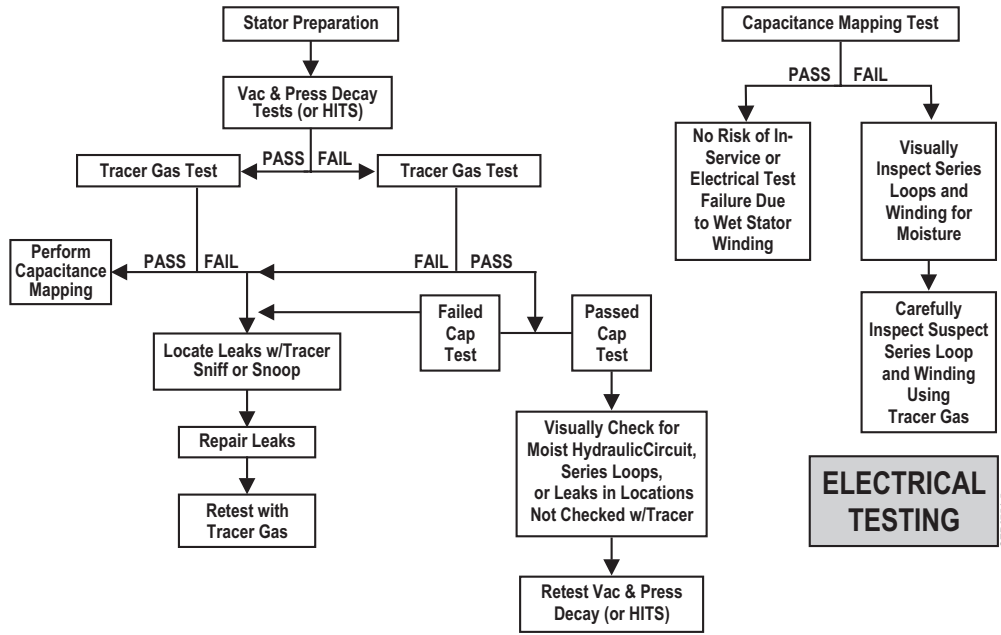
Figure 5. Major outage leak test plan

The standard major outage test program consists of Pressure Decay Test, Vacuum Decay Test, Helium Tracer Gas Test and Stator Bar Capacitance Mapping Testing, as well as electrical testing. During a major outage the field is removed and this facilitates the performance of a Helium Tracer Gas Testing and Stator Bar Capacitance Mapping Testing. An outline for major outage leak testing procedures is given in *Figure 5*.

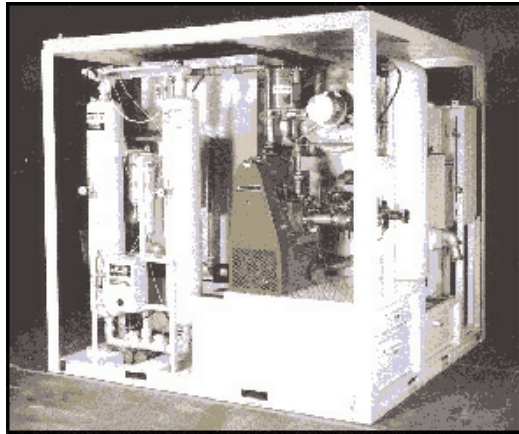
Figure 6. HIT Skid

developed a self-contained, skid-mounted equipment, called a "HIT Skid" (Hydraulic Integrity Test Skid). Hoses from the skid are connected to the generator at specified flanges of the stator. The only external requirement for the skid is a 480 VAC power source at 30 amp. *Figure 6* shows a typical Hydraulic Integrity Test Skid set.

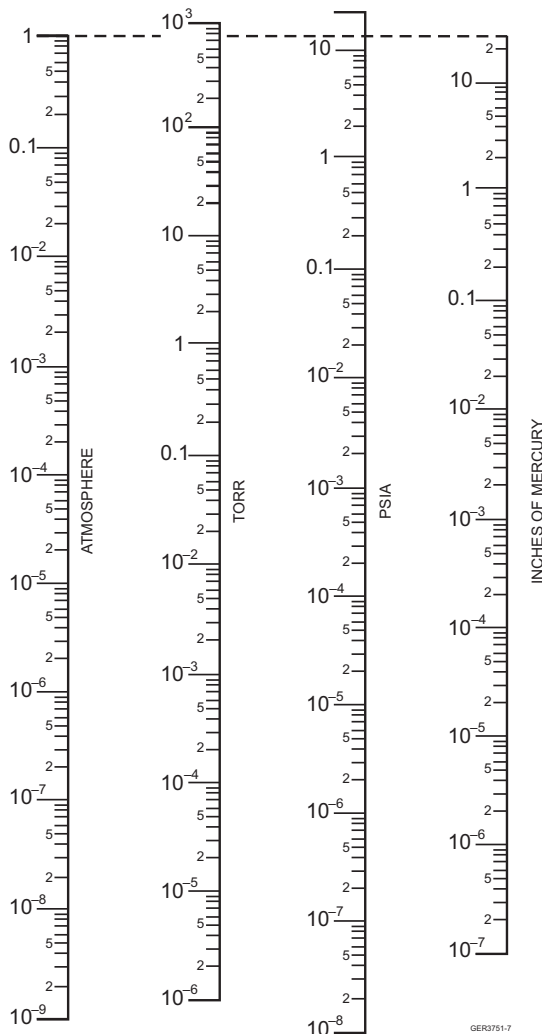
Figure 7. Units of pressure conversion nomograph

Vacuum Decay Testing is a useful tool for determining the integrity of the entire water-cooled stator hydraulic system. The primary advantage to vacuum decay testing is its sensitivity. Decay measurements are made in units of microns. (See *Figure 7*.) As a reference, one micron is equivalent to 0.00002 psi, which is undetectable on a typical pressure gage, yet easily measured with common vacuum gages. The test also measures the leak rate of the entire winding without requiring access to the stator winding.

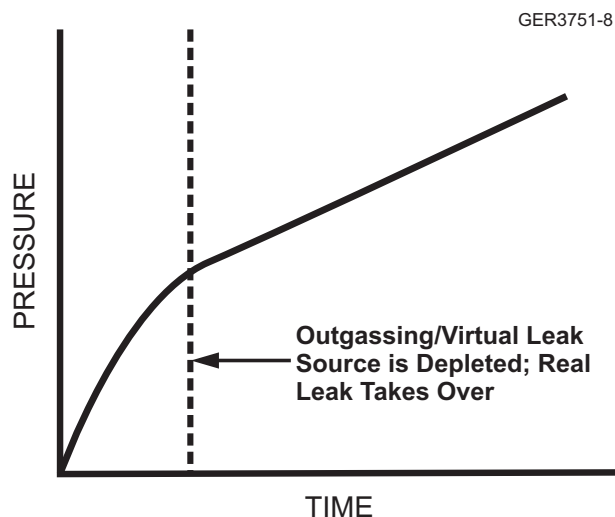
Figure 8. Rate of rise curve (outgassing and leak)

Moisture diffused into the copper oxide surface on the stator bars and the walls of the Teflon™ hoses will outgas at a slow rate. This rate can be high enough to cause the winding to fail the vacuum decay test. By analyzing the vacuum decay data, it is possible to detect the pressure rise due to water outgassing. (See *Figure 8*.) Windings that fail Vacuum Decay Testing and show indications of outgassing must be further vacuum-dried and retested.

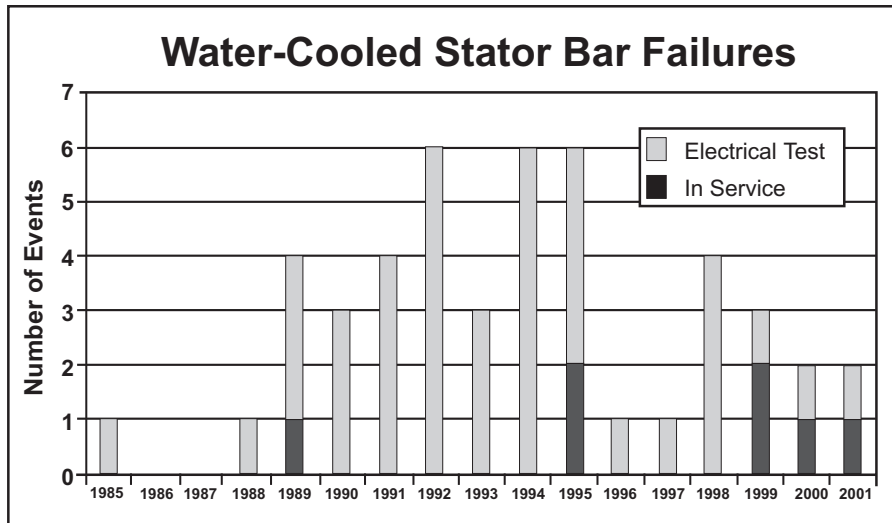
75% of Failures Due to Wet Insulation

Comments for In-Service Failures:

- 1989 One failure probably due to water leak. Cause unknown.
- 1995 Two failures due to abrasion.
- 1999 One failure due to crevice corrosion. One failure due to abrasion.
- 2000 One failure due to leaking copper tube and/or water conductivity.
- 2001 One failure due to cracked tube.

Figure 9. Updated leak test data

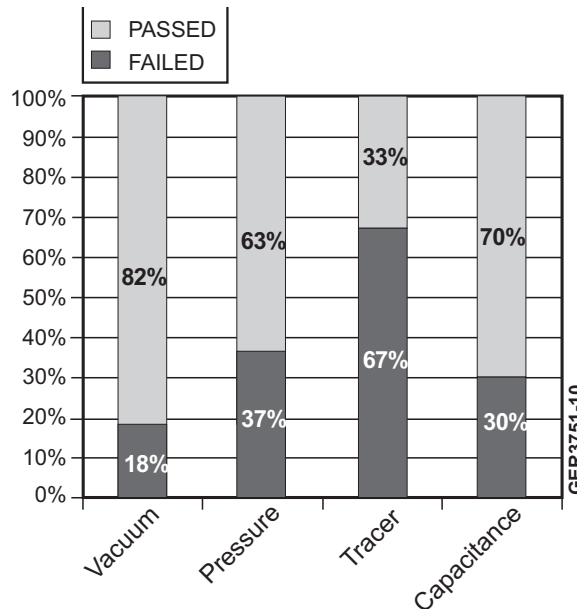
Figure 10. Maintenance test data through May, 2001

A review of the leak-testing history provides evidence that passing both the Vacuum Decay Test and the Pressure Decay Test—though vital in the Maintenance and Inspection Program of Water-Cooled Generators—does not necessarily guarantee a leak-free stator winding. The results demonstrate the importance of Helium Tracer

Gas Testing and Capacitance Mapping Testing. (See Figure 10.) The combination of all these tests provides the best possible assurance that the stator windings are free of destructive water leaks. Our experience indicates that of those generators with windings that failed electrical tests due to wet insulation through May, 2001:

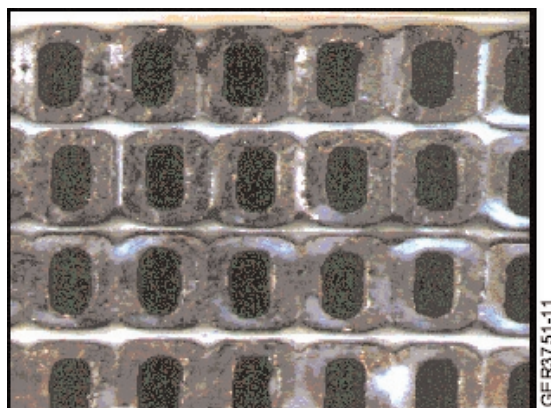
Figure 11. Epoxy-injected clip

Figure 11 shows a typical epoxy-injected clip. The epoxy itself is a specifically formulated compound designed to bond to the oxide layer on the surface of the copper. The stator winding must be dry prior to starting the epoxy injection process. Access is gained by removing the Teflon™ hose and the hydraulic pumping components. The technician directs a syringe’s pinpoint nozzle to the target area aided by a borescope video display. The epoxy is injected into the crevices between the strands. Each diamond shape area formed by the strand corners, as well as between strand columns and rows, is injected to fill any voids. Clips on both ends of

the stator bar need to be injected to ensure that the leak source is sealed. The epoxy is heat-cured and then the clip is inspected and leak-tested. Once the epoxy is cured and the unit has passed the required testing, the procedure is considered to be a permanent repair. This repair is performed by a qualified GE specialist. Prior to performing the epoxy injection repair, the stator bar-to-bar insulation or bar-to-connection ring insulation is removed to verify that the leak is a clip-to-strand leak and not a clip porosity or window leak, which are repaired using other methods. If a clip-to-strand leak is verified, it should be determined that the stator

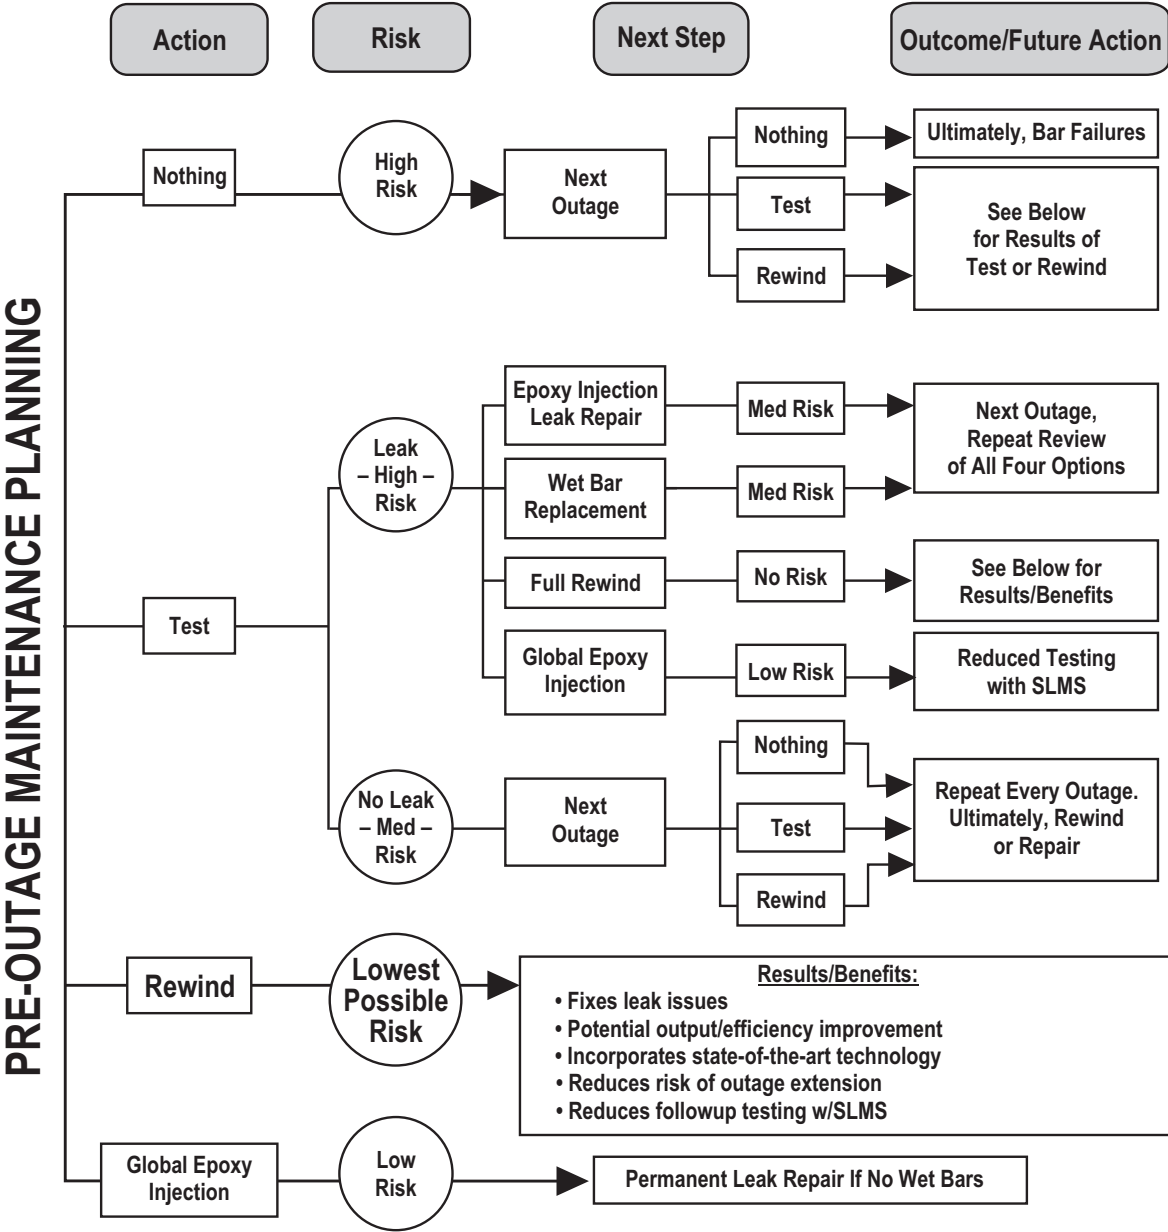
CREVICE CORROSION LEAK TESTING DECISION TREE
